6 July 2023

Saddleworth Institute Condition Report

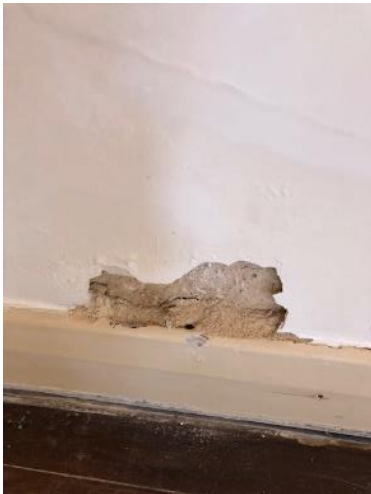
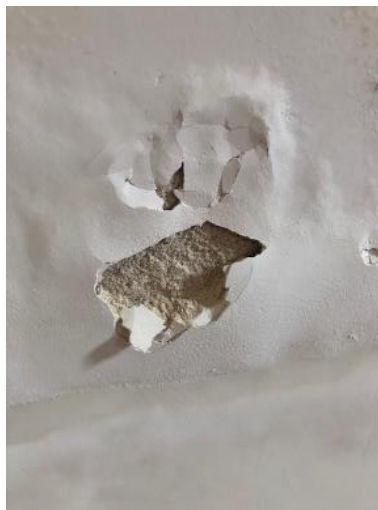
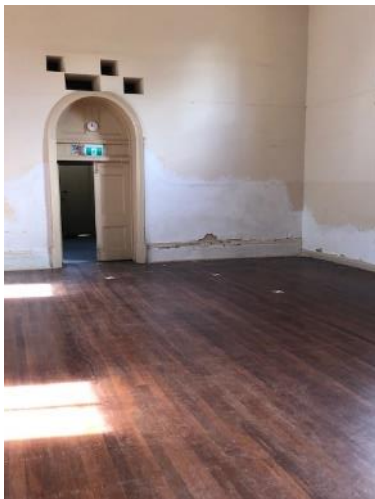
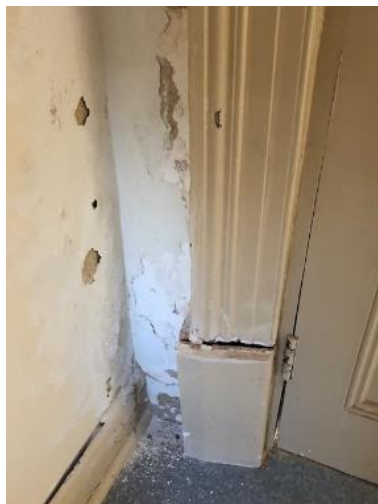
Hence the main problem with this building is moisture, not just under the walls and in the walls but under the entire floor. It was noted in the inspection that the external lower walls have been repointed and the internal walls have been re-plastered.

It is my understanding that the Council has made a concerted effort with modern chemical damp proofing methodology in the form of liquid chemical barriers to control the issues with dampness.

This system has obviously been ineffective in controlling the rising damp as seen by the condition of the new plastering which is delaminating and the underlying render deteriorating as well. See below

In my opinion the only way to permanently rectify this problem is to install a physical Damp Proof Membrane (DPM) to all stone walls. The timber floor in the main hall is showing signs of warping due to moisture ingress.

These floors would need to be removed to gain access to the internal walls to effectively install the DPM. Once the timber floors are out of the way the area underneath can be treated for rising damp.

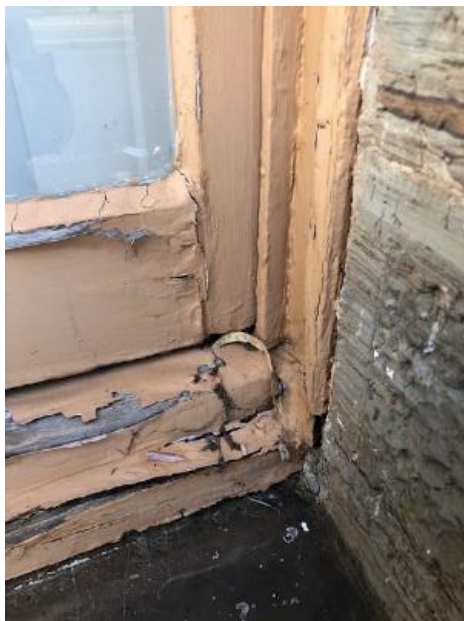
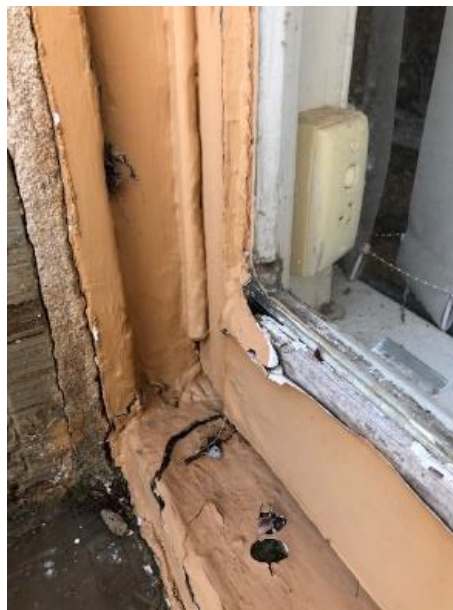
Windows

The windows across the front of the institute need to be replaced. See below:

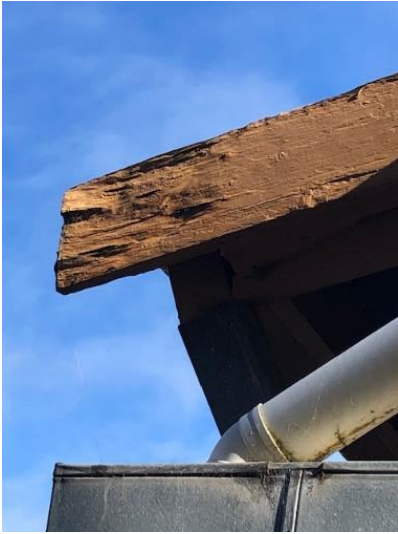
Timber Work

Some of the timber on the institute needs to be replaced as they have not been adequately maintained over the years. Other areas need to be repaired and painted (see image left).

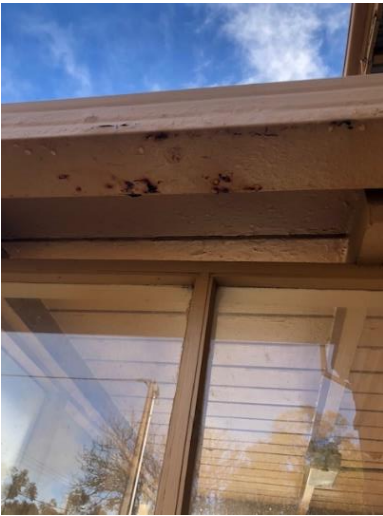
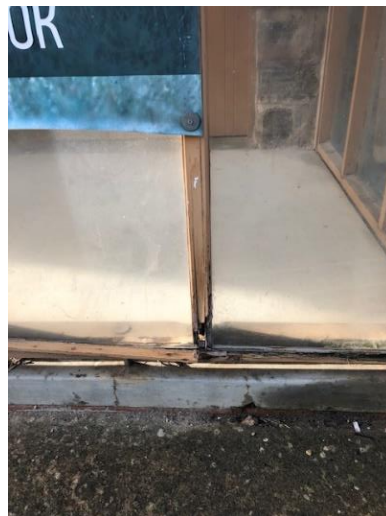
Front Porch

The front porch is in very poor condition, gutters need to be replaced, and the frame is also in need of new timber work. The option would be to remove the porch altogether if not required.

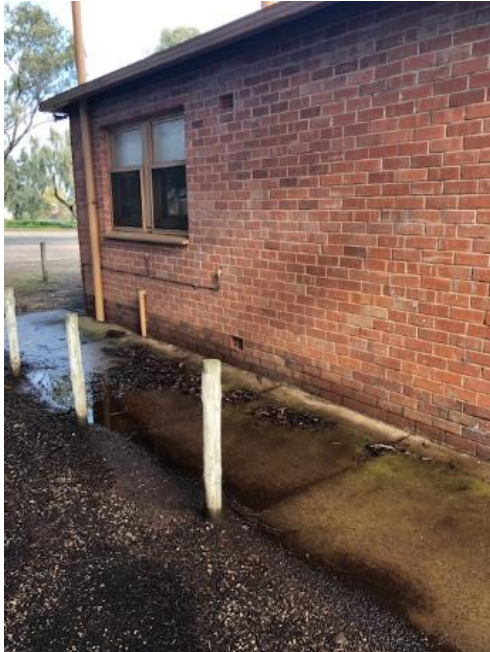
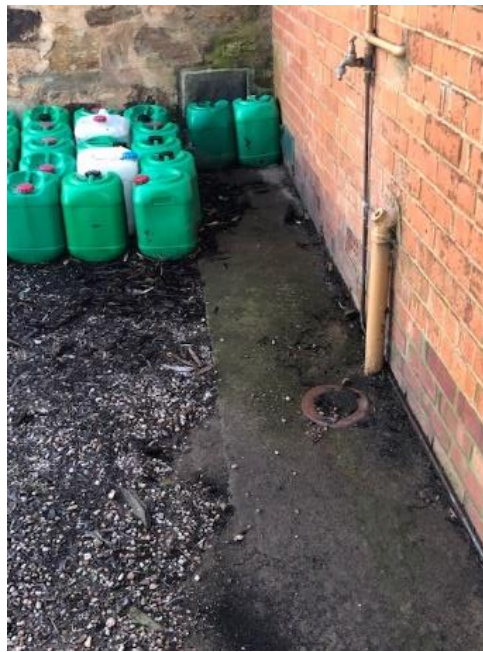
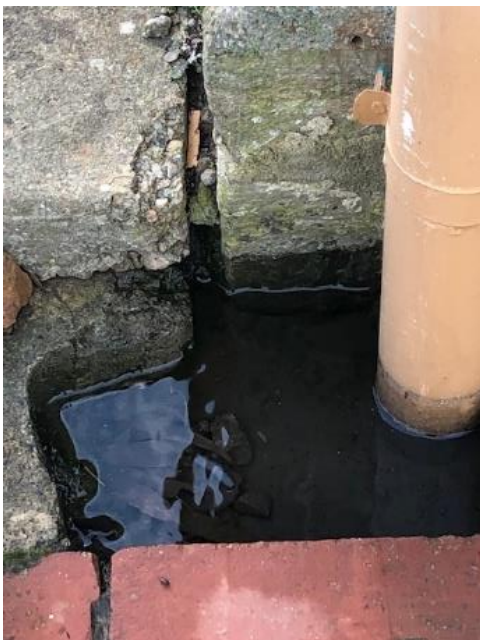
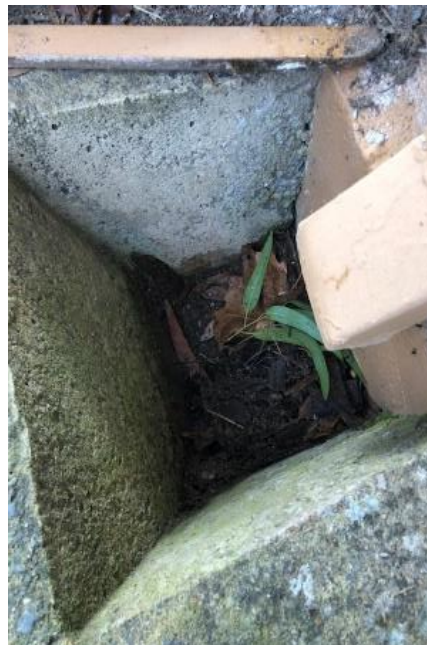
Drainage around building.

It was noted that the building has very poor drainage around the perimeter which no doubt contributes to the dampness in the walls.

Some drainage pits at down pipes are full of water, pipes probably blocked, one drain at the front doesn't appear to have a pipe connected. See Below

As demonstrated in this report, some immediate maintenance is required and alteration to how water is to get away from the building. The building is
